REPORT OF THE TECHNICAL COMMITTEE ON

THE PROPOSED PURCHASE OF LR. NO. 7258/46 ALONG GIGIRI ROAD FOR CABINET OFFICE SPACE

ON 22ND EBRUARY 2013

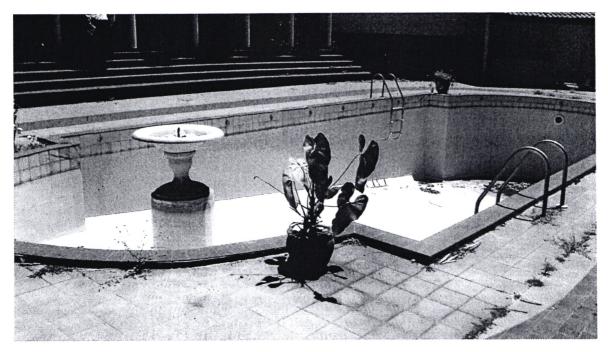
The swimming pool

- 4. Stone perimeter fencing with security installations
- 5. Provide Library/ boardroom
- 6. Swimming pool to be backfilled and the area be landscaped to include a water feature

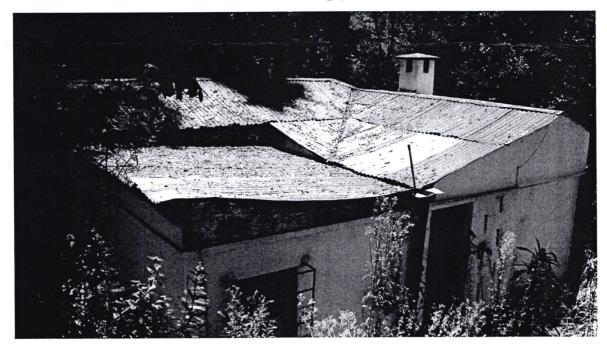
The domestic servant's quarter

- 1. Gate and gate house
- 2. Security officers quarters with an armoury (two bedrooms house)
- A Gazebo for outdoor functions with landscaped lawns to take tents. Existing old domestic servant quarters to be demolished.

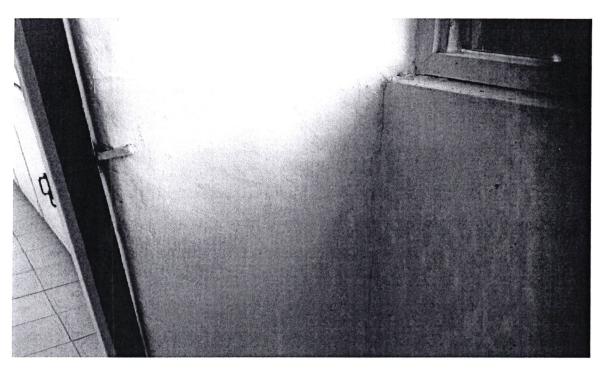
A minor vertical crack on one of the walls (the crack does not pose any structural challenge)

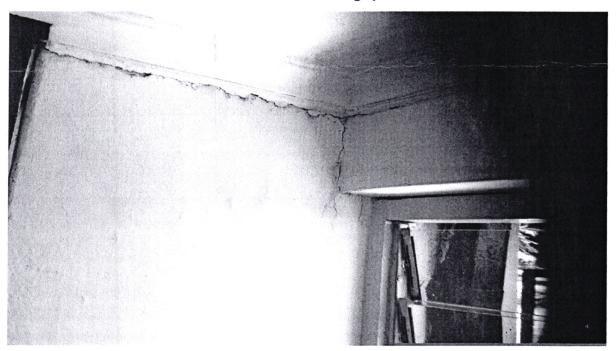
A minor horizantal crack on one of the walls (the crack does not pose any structural challenge)

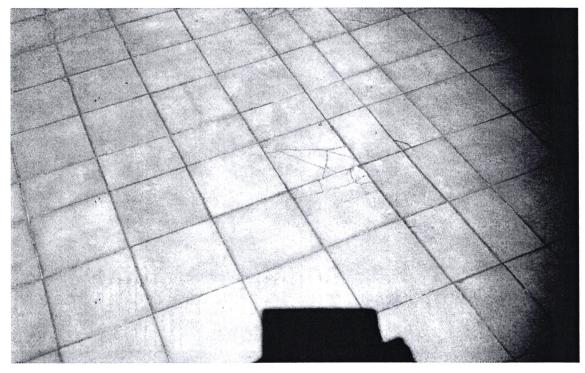
A minor thermal crack on the swimming pool terrace slab
